SEVENTH ENDORSEMENT on VMF-334 AAR ser 1-58 concerning F8U-1 BUONO 143763  
accident occurring 10 July 1958, pilot BLACK

Subj: Aircraft Accident Report; forwarding of

FIFTH ENDORSEMENT on VMF-334 AAR ser 1-58, concerning F8U-1, BuNo. 143765, accident occurring 10 July 1958, pilot BLACK

Subj: VMF-334 AAR serial 1-58

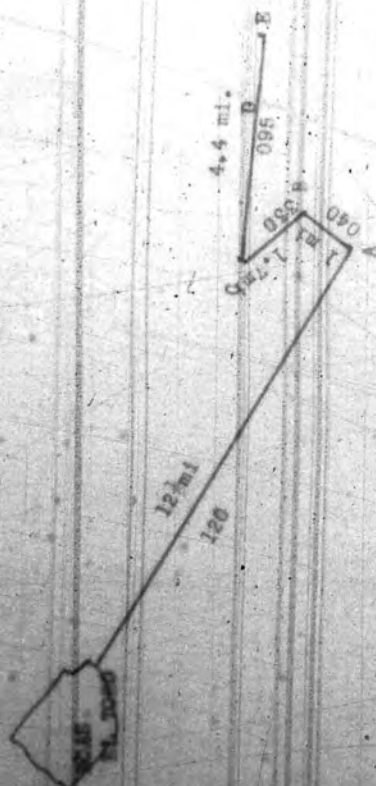
MAP OF 1/6 ACCIDENT OF FSU ON 7-10-55, SHOWING HEADINGS AND  
DISTANCES OF CRASH SITE, WHERE SEAT AND CANOPY FOUND, PROBABLE  
POINT OF EJECTION, AND WHERE PILOT LANDED.

A-Canopy Found  
B-Seat Found  
C-Pilot Landed  
D-Probable point of ejection  
E-Site of FSU crash

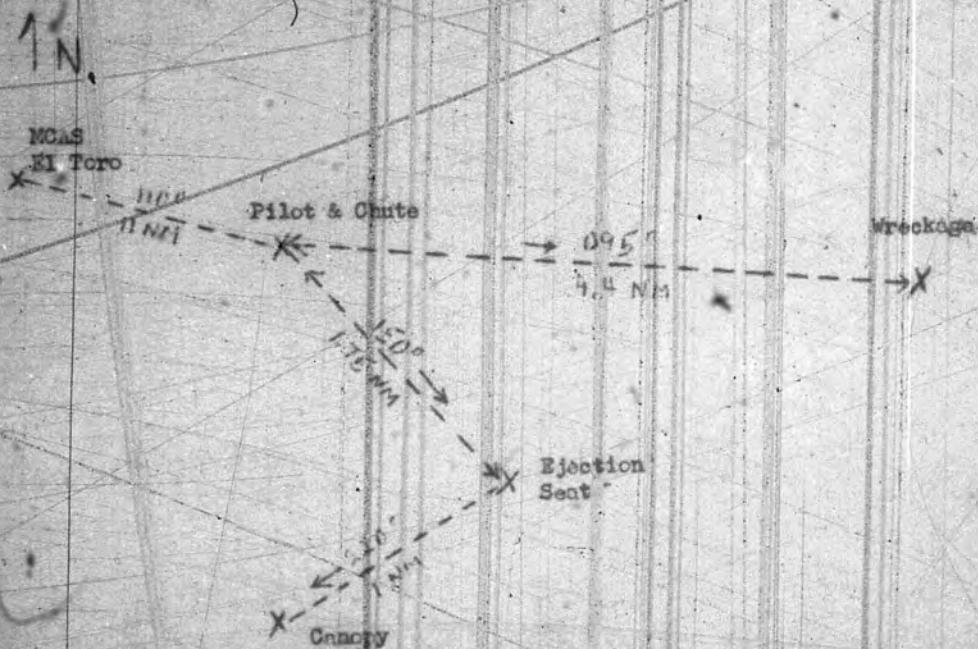
Diagram of relative positions of canopy, seat, pilot and parachute and aircraft wreckage.

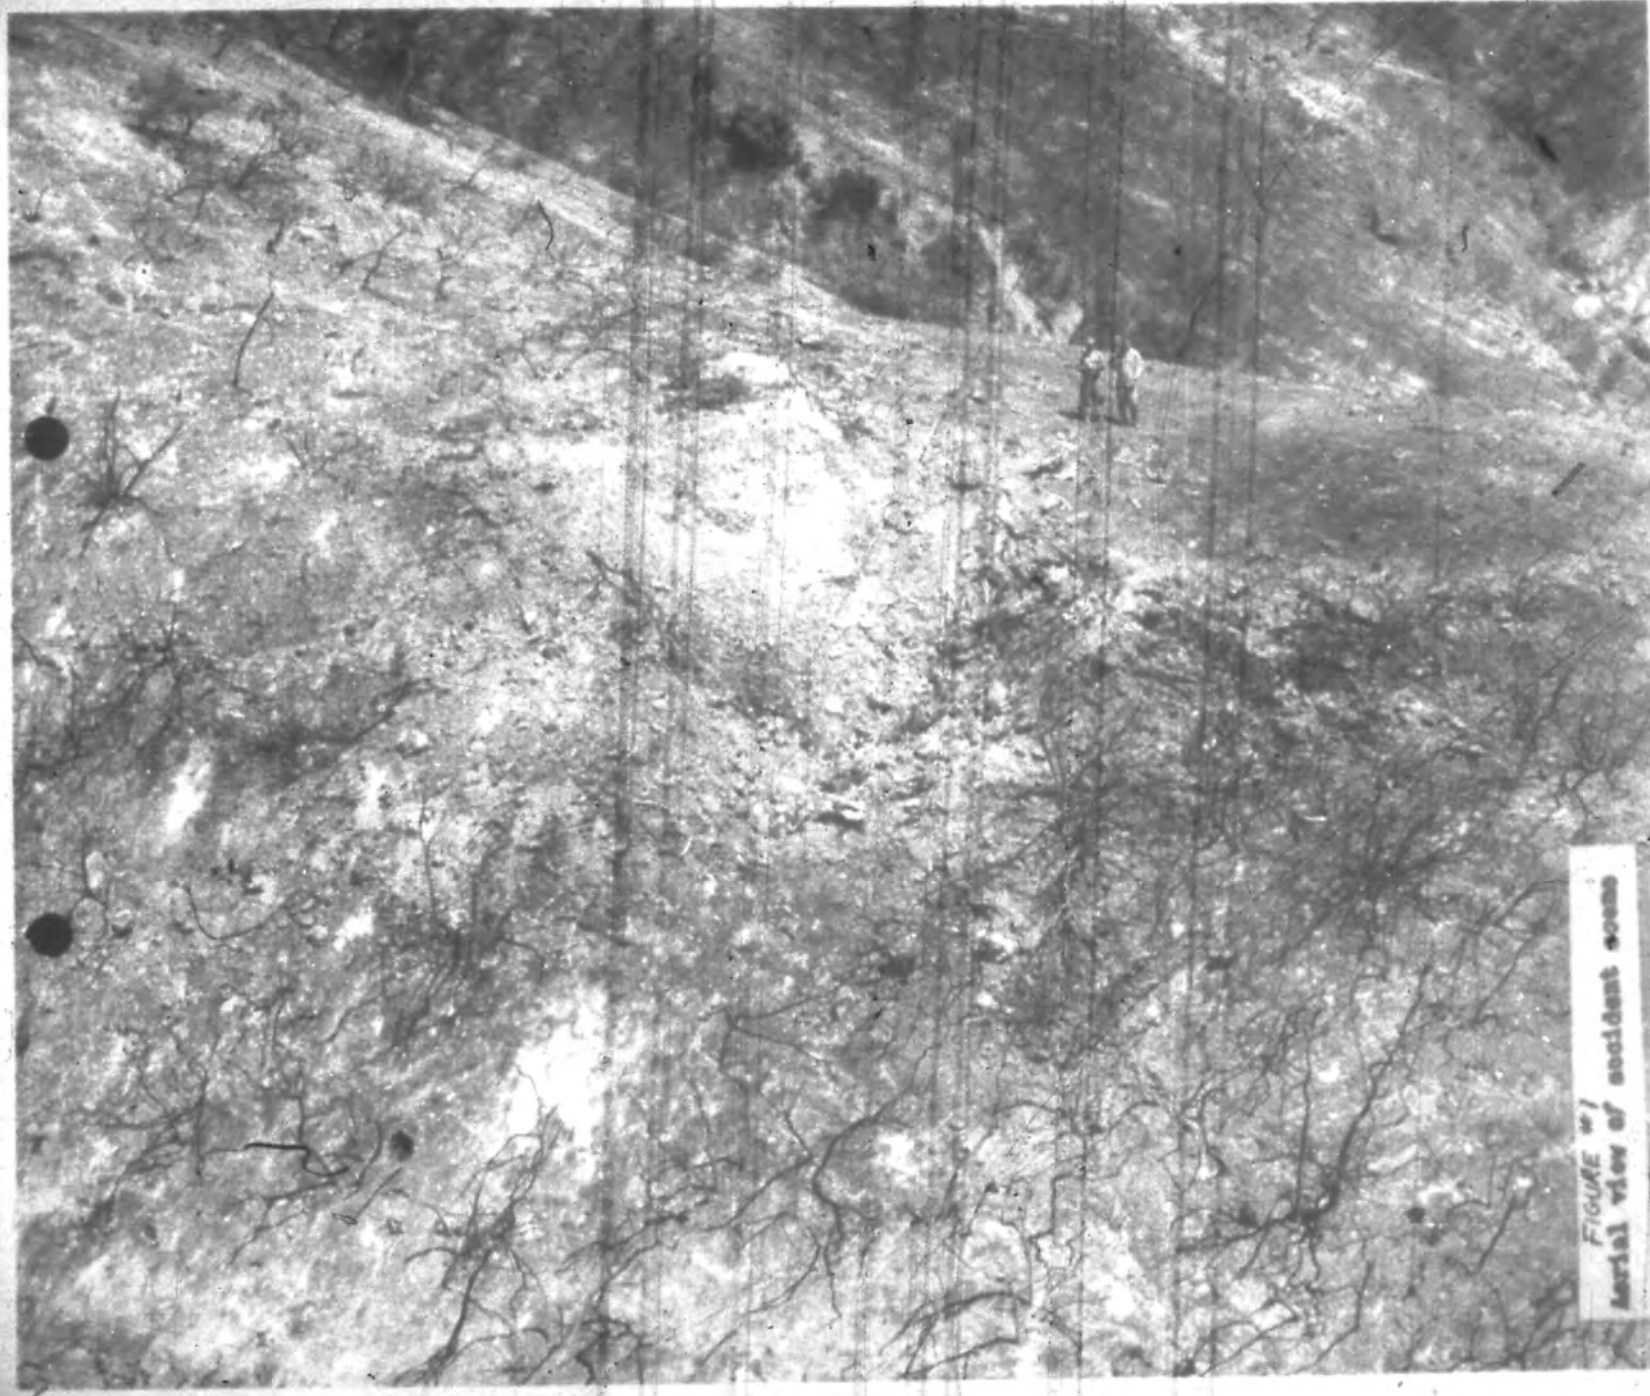
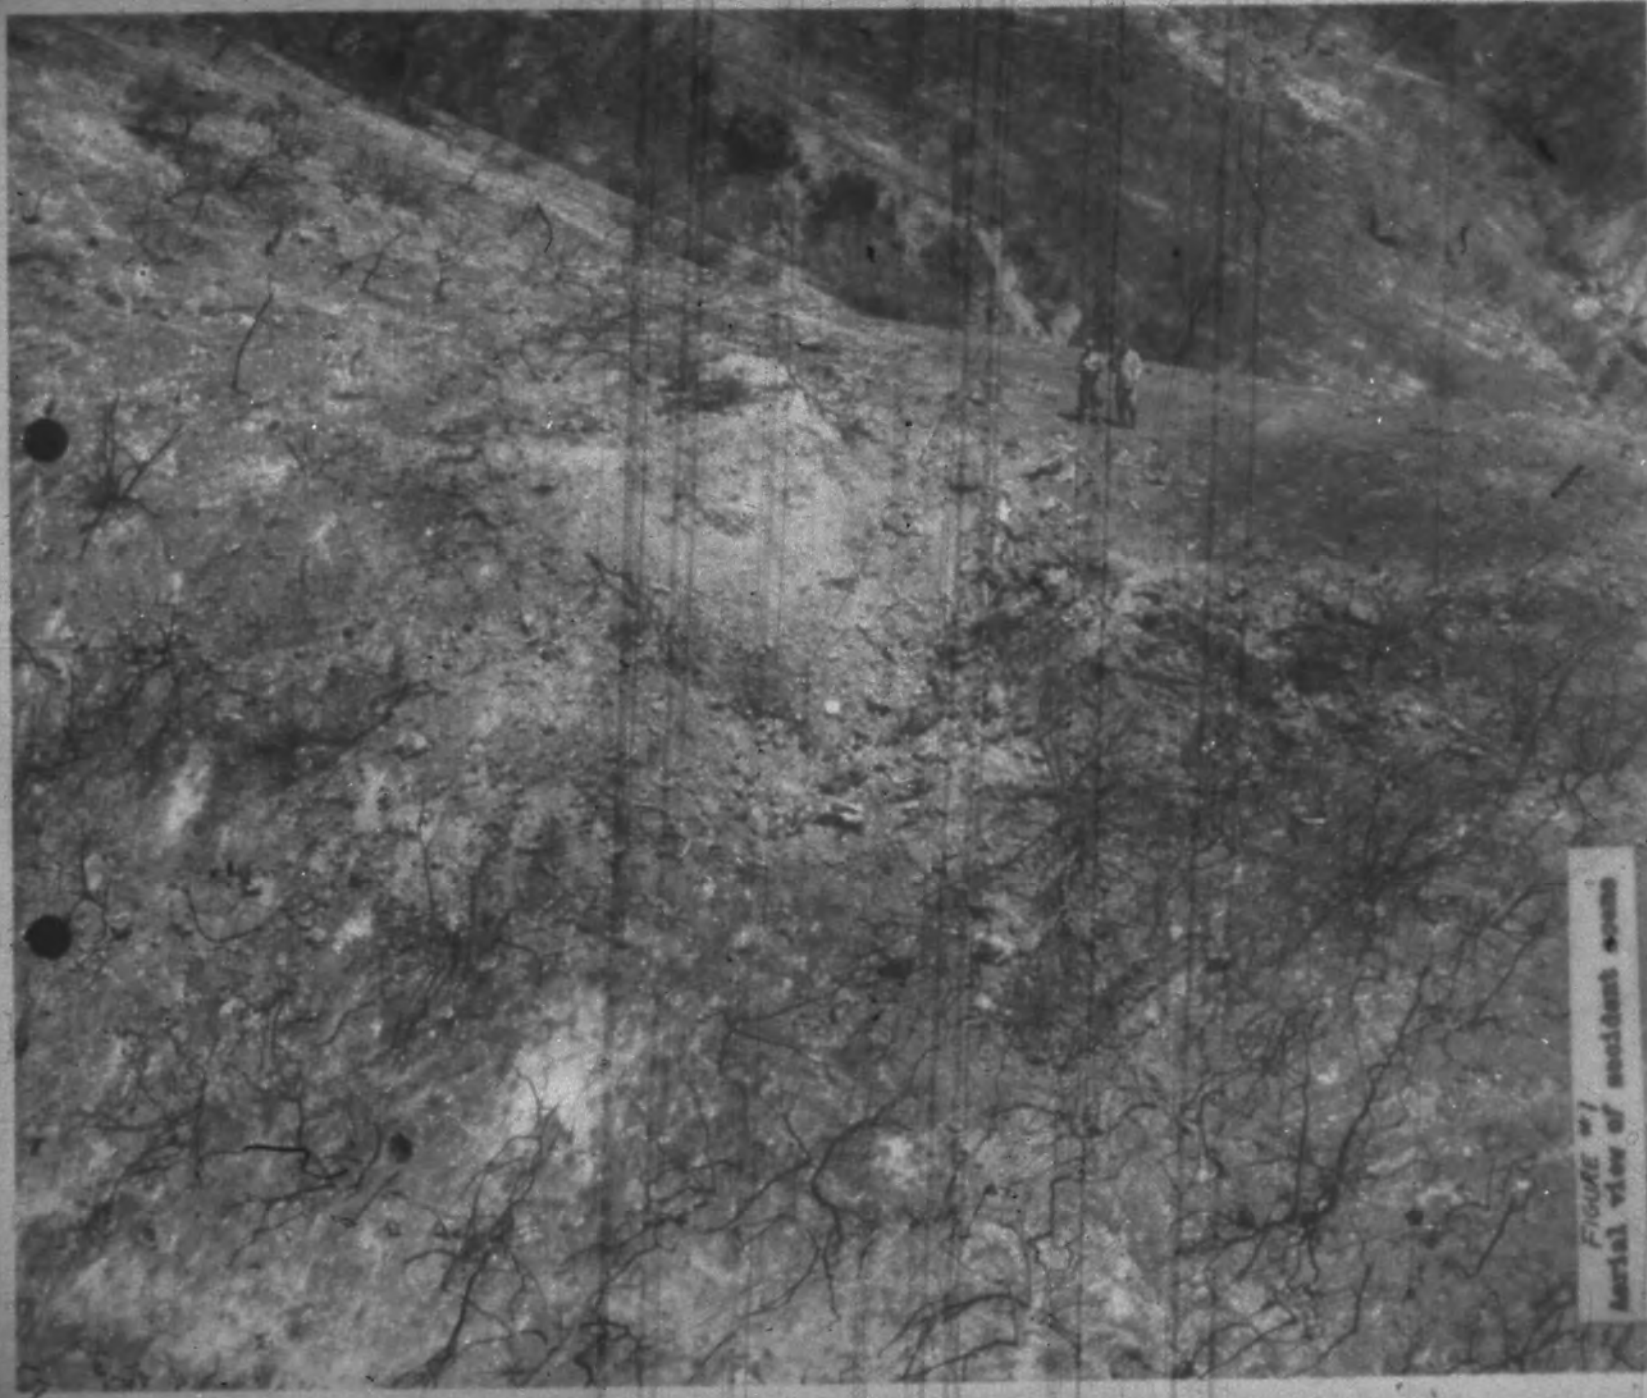
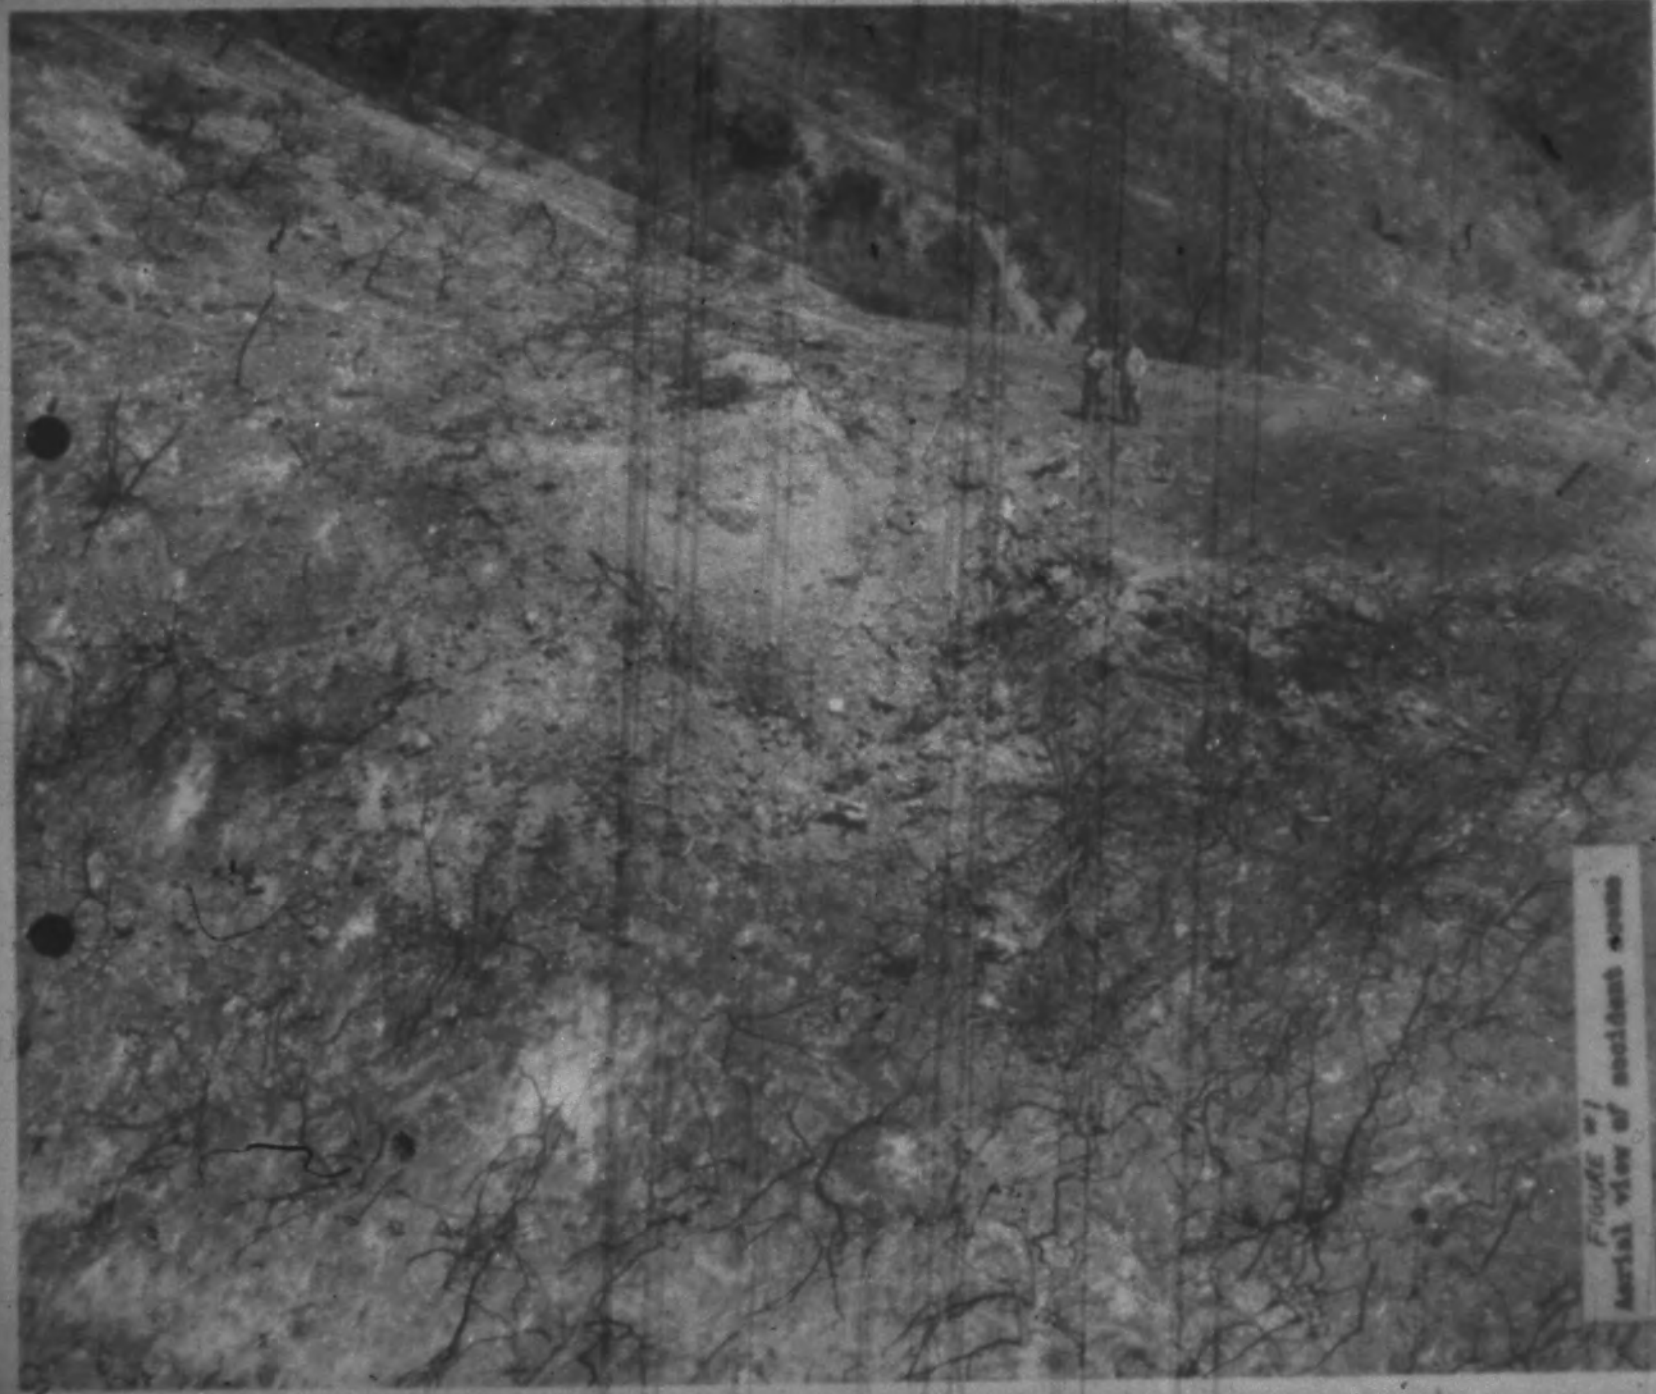
After the pilot ejected, or was ejected, the aircraft rolled into a steep nose down starboard turn with the engine operating at full power including afterburner. The aircraft received strike damage when it crashed on the East slope of Nickel Canyon at a point approximately 10 miles bearing  $110^{\circ}$  from MCAS, El Toro. The aircraft exploded on impact with the terrain. The attitude of the aircraft on impact was approximately  $70^{\circ}$  nose down. Its heading was approximately  $095^{\circ}$ . The airspeed of the aircraft was approximately 650 knots. The force of the impact and the ensuing explosion gouged a hole in the hillside which measured 38 feet long, 31 feet wide, and 12 feet deep (see enclosure 7, figure #1). Small parts of wreckage were scattered over a wide surrounding area.

FIGURE #1  
Aerial view of accident scene

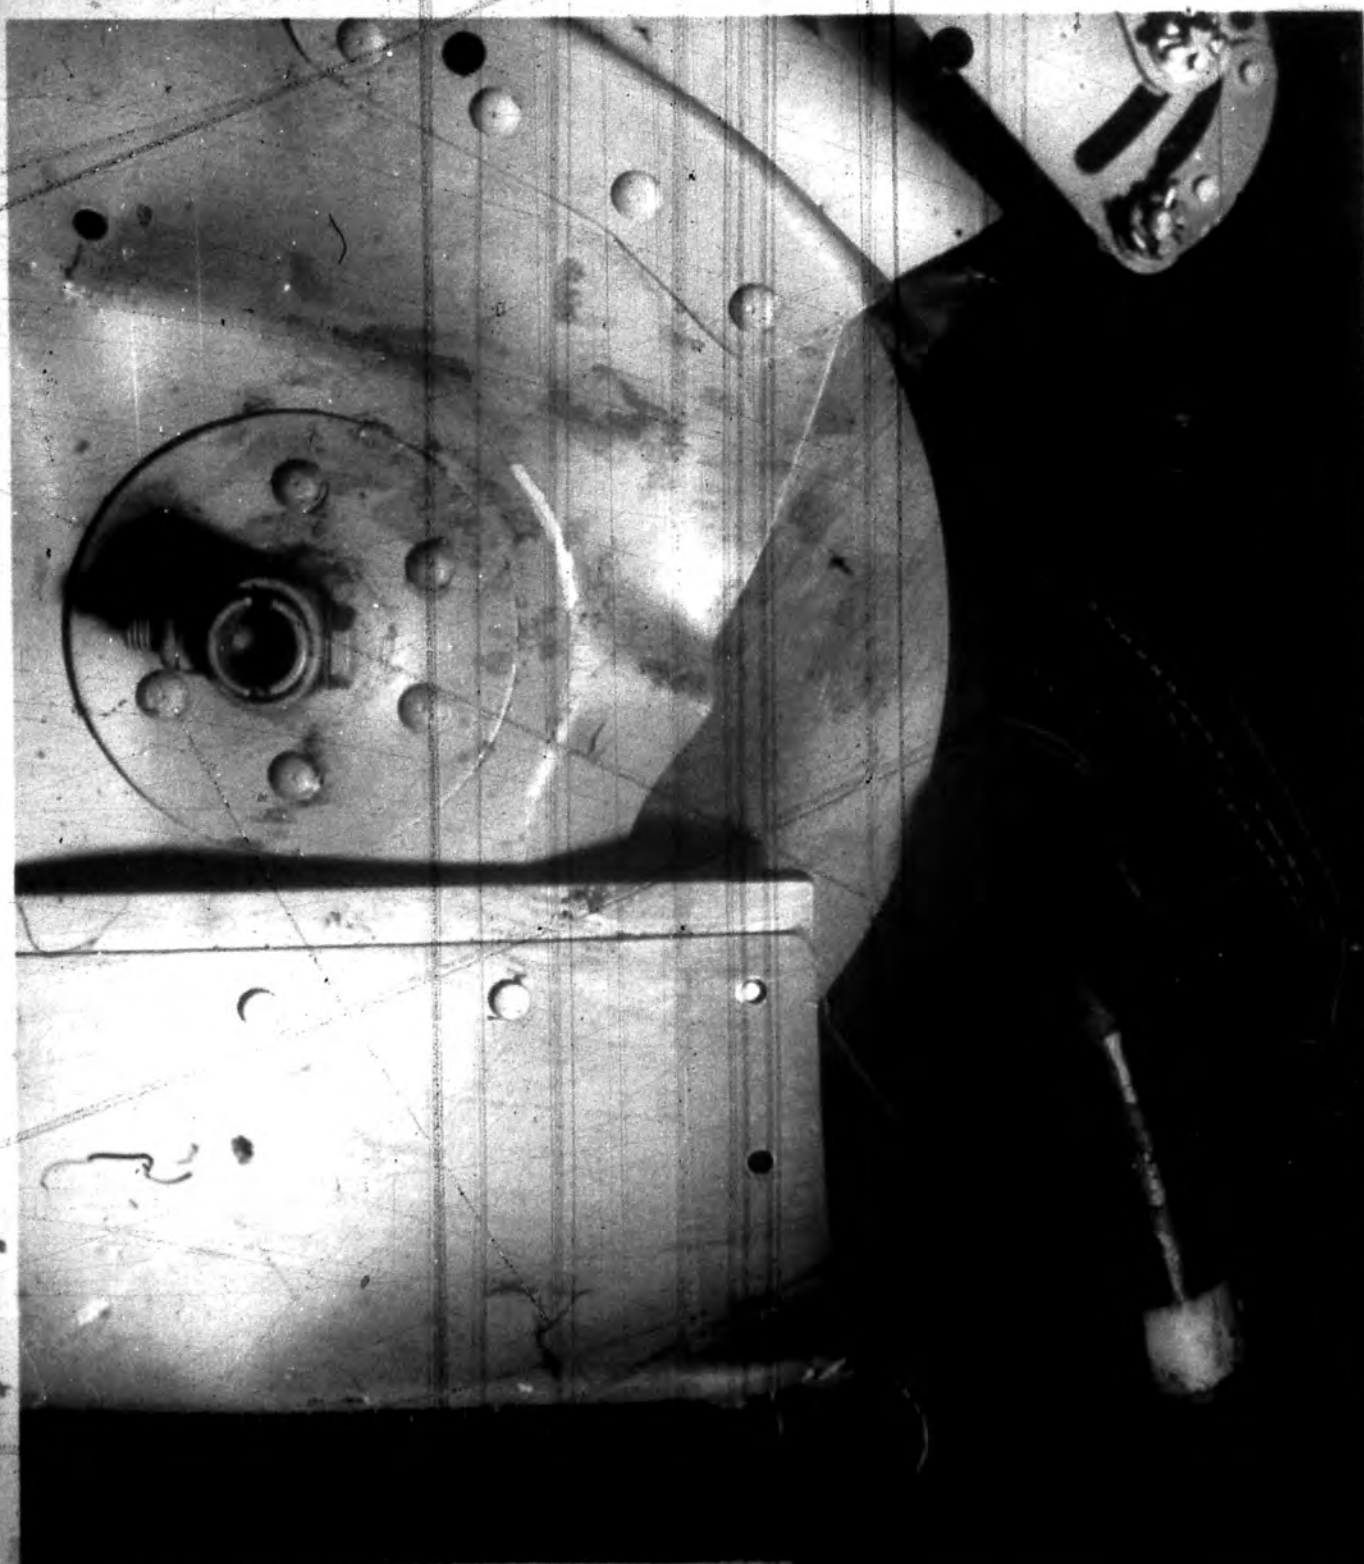
FIGURE 2  
Head rest showing elongated rivet holes  
where face curtain housing is mounted (right side)

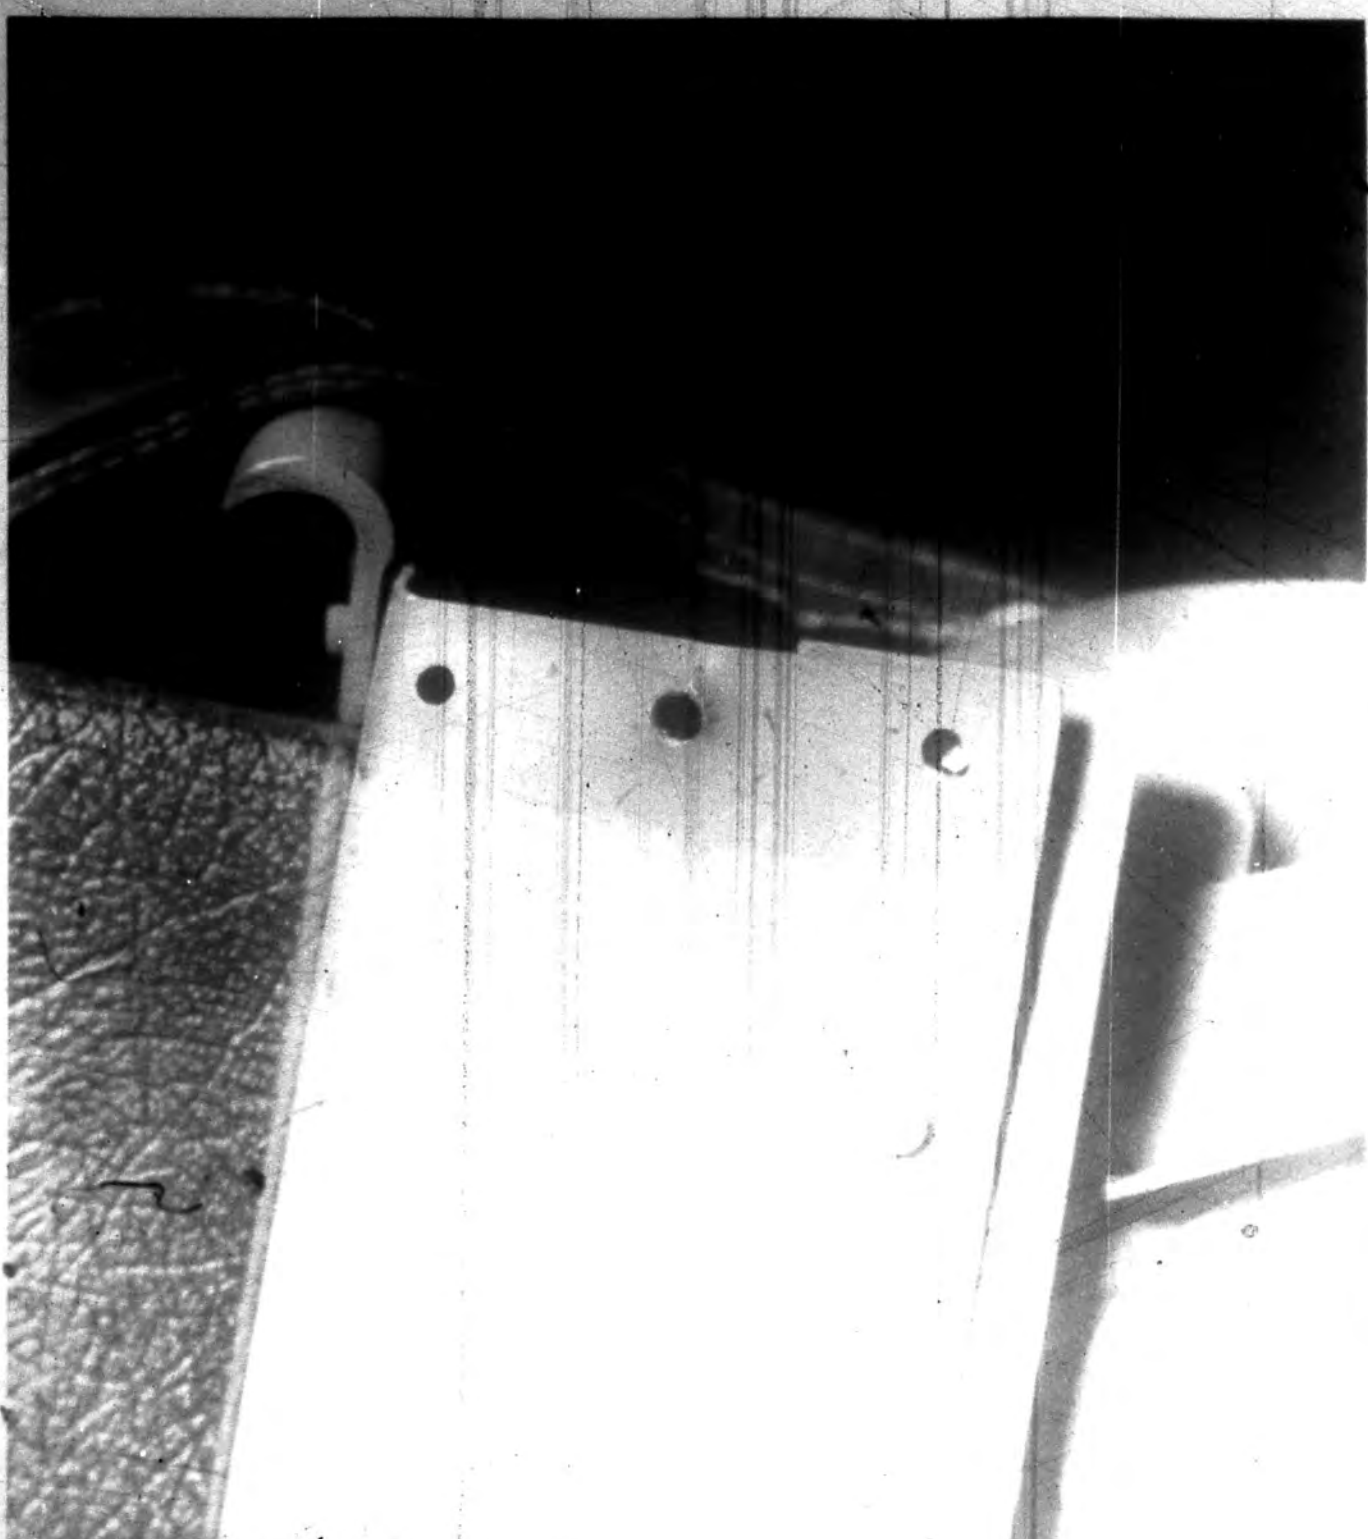
FIGURE #3

Head rest showing elongated rivet holes  
where face curtain housing is mounted (left side)

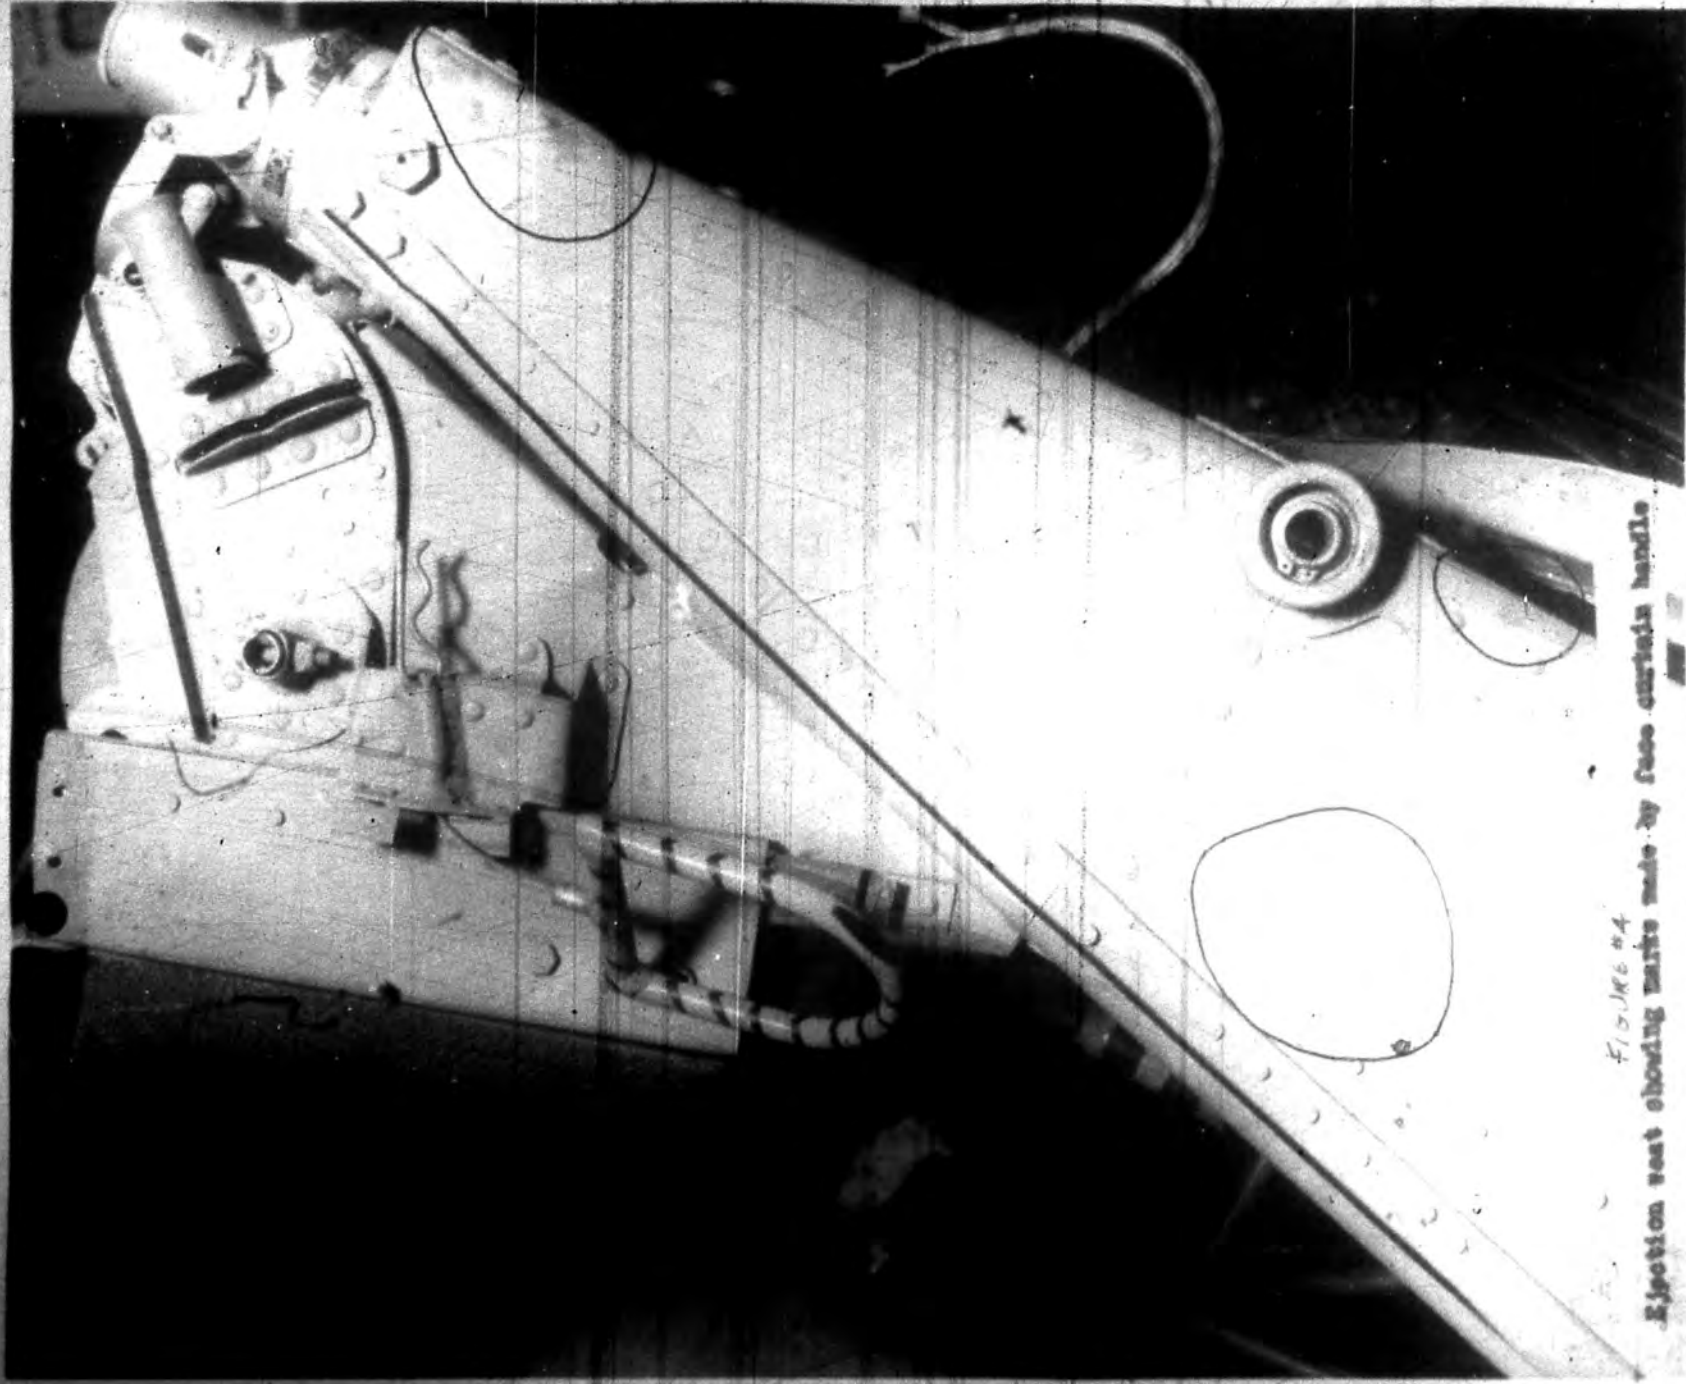
FIGURE #4  
Ejection seat showing marks made by face curtain handle

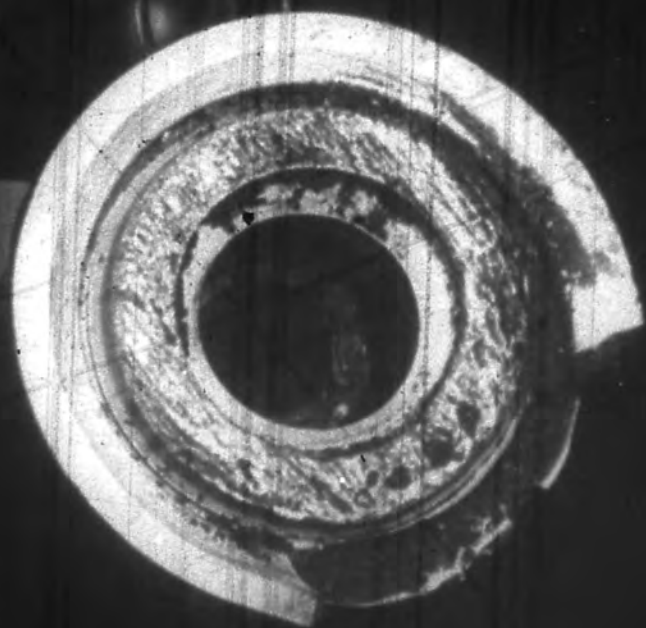
FIGURE #7  
Emergency canopy actuator CYLINDER

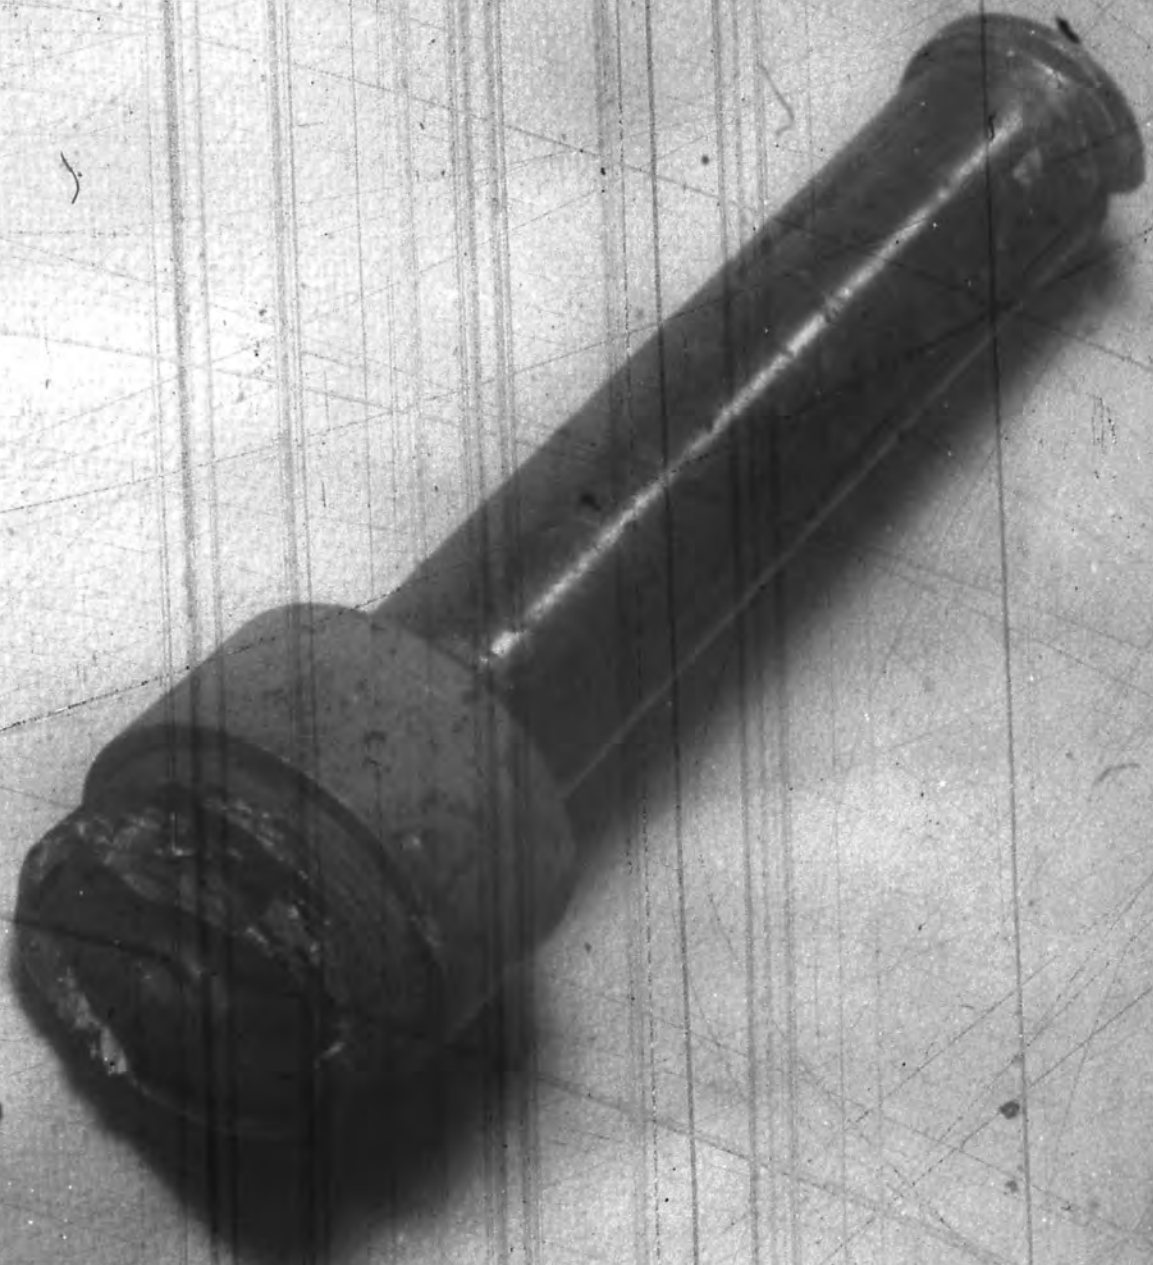
FIGURE 8  
Emergency canopy actuator CYLINDER.

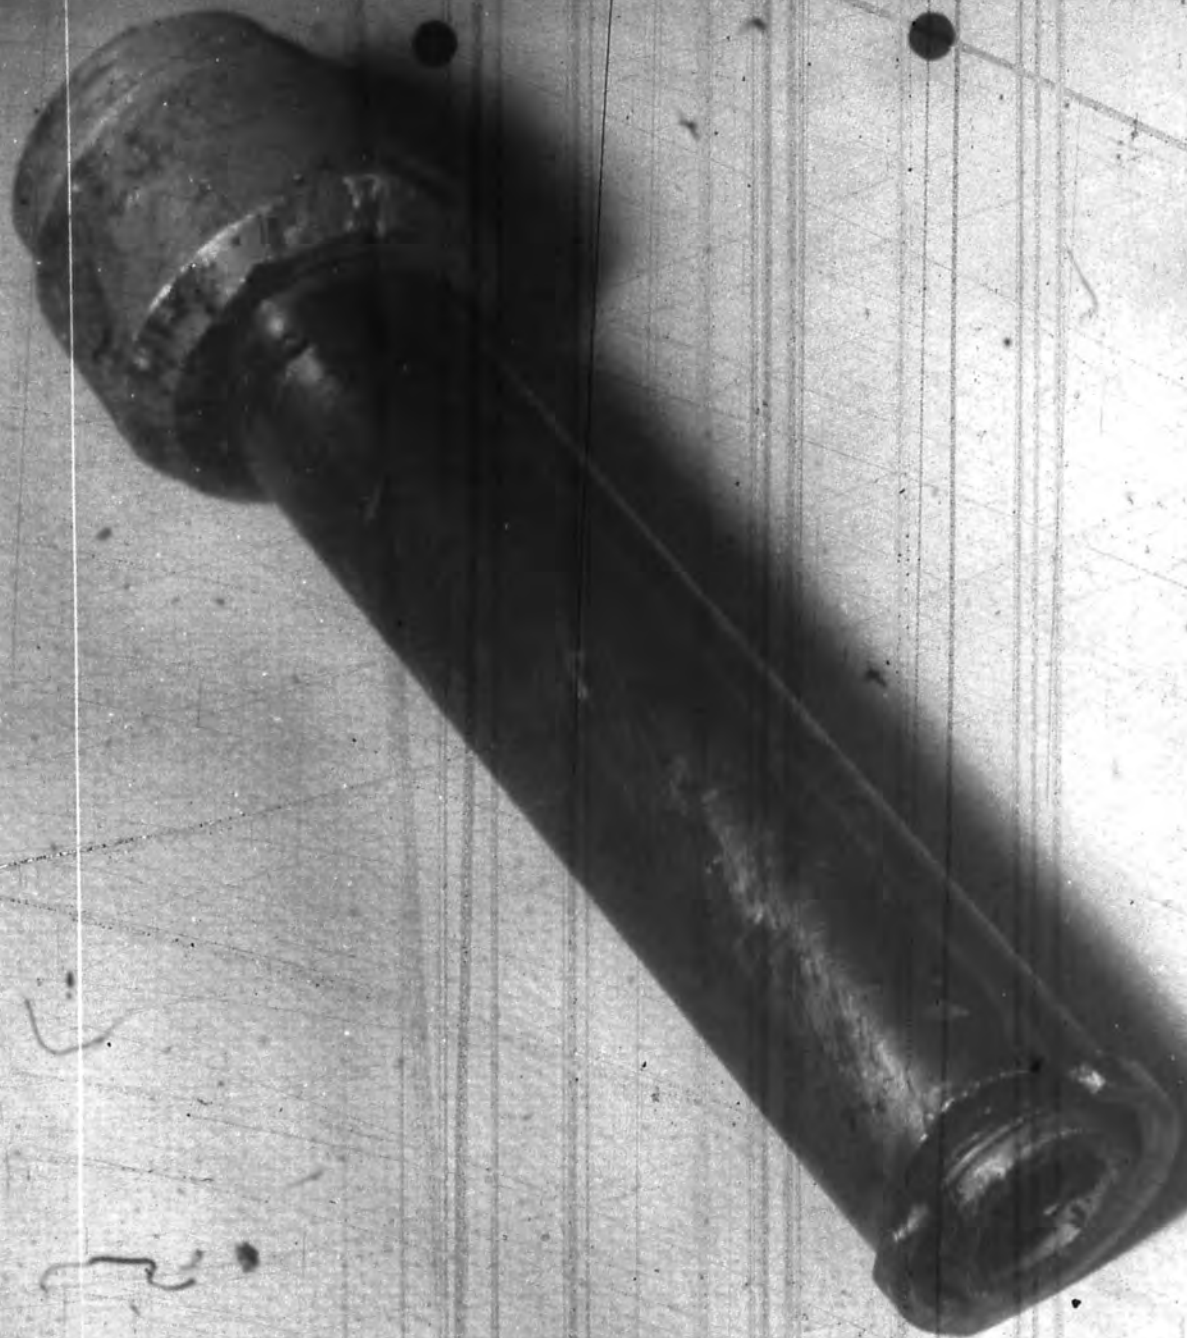
FIGURE #9  
Emergency canopy actuator CYLINDER

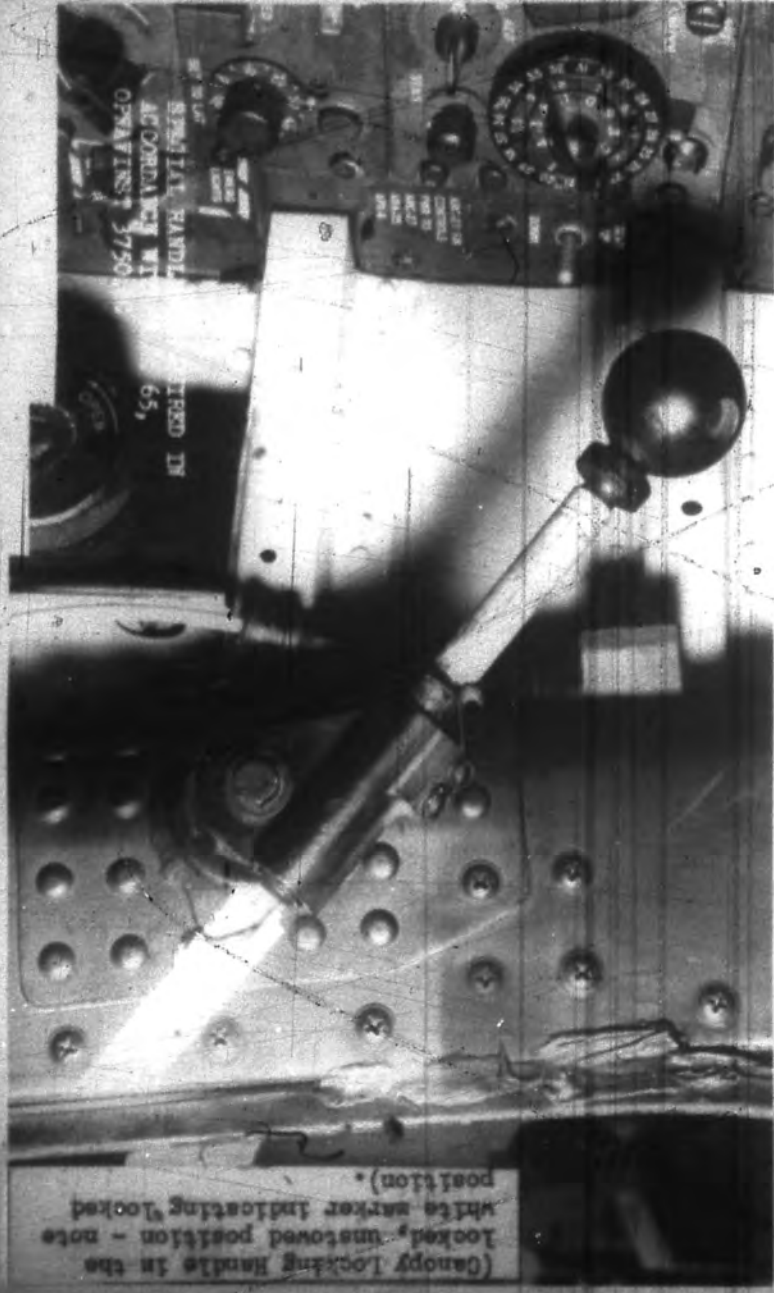
(Canopy Locking Handle in the locked, unstowed position - note white marker indicating 'locked position').

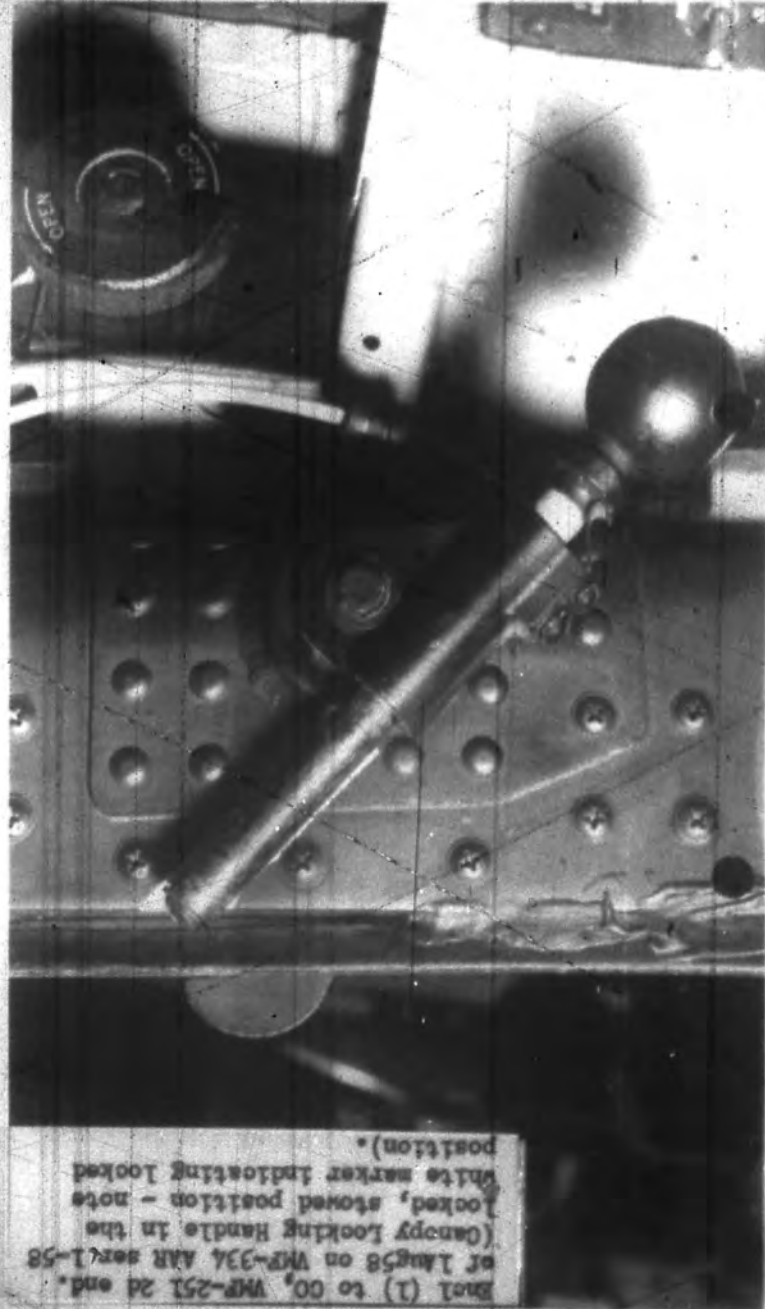
Encl (1) to OO, WAF-251 2d and. of Lang 58 on WAF-334 AAR ser 1-58 (Canopy Locking Handle in the locked, stowed position - note white marker indicating 'locked position').
