SEVENTH ENDORSEMENT on VMF-334 AAR ser 1-58 concerning F8U-1 BUONO 143763  
accident occurring 10 July 1958, pilot BLACK

Subj: Aircraft Accident Report; forwarding of

FIFTH ENDORSEMENT on VMF-334 AAR ser 1-58, concerning F8U-1, BuNo. 143765, accident occurring 10 July 1958, pilot BLACK

Subj: VMF-334 AAR serial 1-58

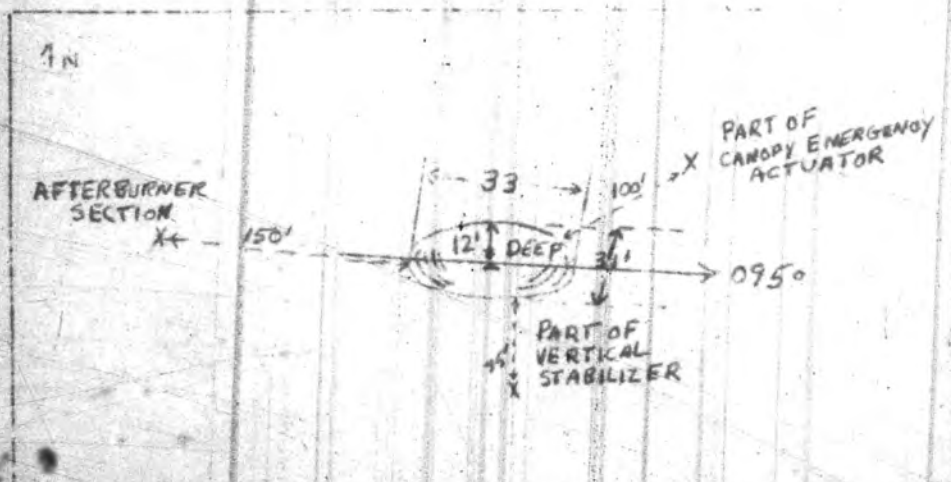
DIAGRAM OF CRASH SCENE

Note: The force of the explosion on impact disintegrated the aircraft and scattered the parts over a wide area. Most of the parts were unrecognizable thereby making it impossible to include all parts in the diagram.
